**DEPARTMENT OF TRANSPORTATION**

Contract #: 04-0120F4Cty: SF/ALA Rte: 80 PM: 13.2/13.9File #: 1.28**WELDING INSPECTION REPORT****Resident Engineer:** Casey, William**Address:** 333 Burma Road**City:** Oakland, CA 94607**Report No:** WIR-029575**Date Inspected:** 07-May-2013**Project Name:** SAS Superstructure**OSM Arrival Time:** 700**Prime Contractor:** American Bridge/Fluor Enterprises, a JV**OSM Departure Time:** 1730**Contractor:** American Bridge/Fluor Enterprises, a JV**Location:** Job Site**CWI Name:** As noted below**CWI Present:** Yes No**Inspected CWI report:** Yes No N/A**Rod Oven in Use:** Yes No N/A**Electrode to specification:** Yes No N/A**Weld Procedures Followed:** Yes No N/A**Qualified Welders:** Yes No N/A**Verified Joint Fit-up:** Yes No N/A**Approved Drawings:** Yes No N/A**Approved WPS:** Yes No N/A**Delayed / Cancelled:** Yes No N/A**Bridge No:** 34-0006**Component:** SAS OBG**Summary of Items Observed:**

## WELDING INSPECTION REPORT

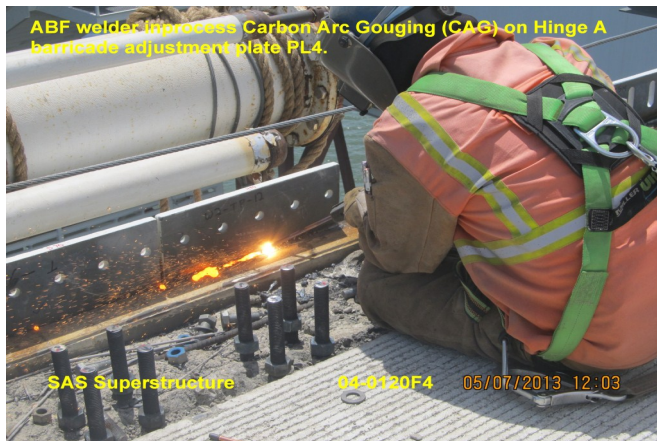
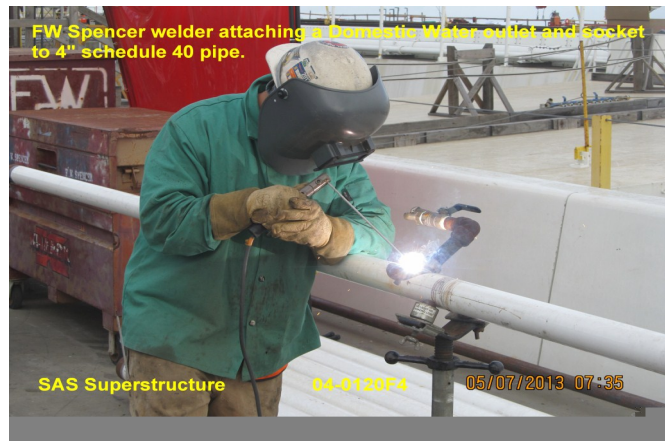
This QA Inspector randomly observed ABF welder Lin E Yun #9344 back-gouging the opposite side of the root on the Hinge A barricade adjustment plates 5-8 (PL5, PL6, PL7 and PL8) on the south side of the westbound OBG utilizing the Carbon Arc Gouging (CAG) method. The welder was observed performing proper arc gouging procedures to avoid the retention of carbon deposits and material or dross in the areas which are to be welded and utilizing a small disc grinder to ground the back gouged area to bright metal.

FW Spencer welder Tim Esquivel #8348 was observed performing SMAW welding on 4" schedule 40 pipe sockets and outlets. The welder was observed utilizing WPS-1-12-1 and pre-heating the surface area to be welded prior to welding. Other welding parameters as inspected by the QC Inspector appeared to be in compliance with the WPS noted above. This QA Inspector made random observations throughout the shift and noted that the work was completed on this date and appeared to be in general conformance with the contract documents. Completed work on this date includes weld identification #'s; 1/DW1/92.5/BE and 1/DW1/91.5/BE.
